## Electrical Equipment Incident Report

REPORT NUMBER: IR201632f

<b>EQUIPMENT TYPE:</b>	Liquid Heating Appliance	Bread Toaster	Socket Outlet	Kitchen Machine
<b>BRAND/TRADENAME:</b>	Home&Co	Unknown	Unknown	Vorwerk
<b>DETAILS:</b>	WK831, 240V, 1850-2200W	Unknown	Unknown	Thermomix 31-1, 220-240V~,50/60Hz 1500W
<b>HAZARD CLASSIFICATION:</b>	Fire			
<b>INCIDENT LOCATION:</b> <small>(SUBURB)</small>	DUGANDAN

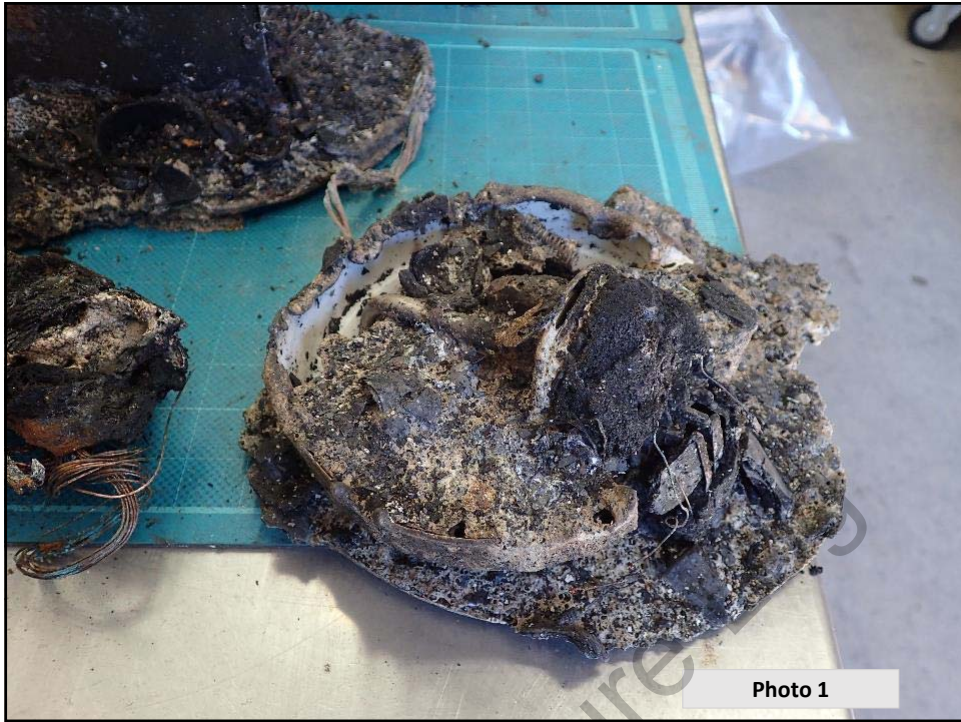
1

The submitted samples included the remains of an electric kettle (Photo 1) with a request to examine for suspected pitting in the kettle heating element as possible evidence of an electrical source of ignition of fire. A toaster (Photo 2) was also submitted with a request to examine it for evidence to rule out as an ignition source. A badly damaged kitchen machine submitted (Photo 3) was identified as a Vorwerk brand, model Thermomix. This was confirmed by the rating markings found under the machine (Photo 4). Two fire damaged wall socket outlets were also provided (Photo 5& 6).

The kettle was identified as a Home&Co brand, model WK8321. This kettle was a cordless type removable in normal use from its plastic base containing an electrical mains connection. Even though the plastic kettle had melted down to its base the underside of the kettle base was not badly damaged and the identifying rating label was able to be read (Photo 9). The heating element was found undamaged (Photo 10) with no pitting evident. A concentration of fire damage with charred plastic was observed around the cordless kettle connector at the base and rear of the kettle (Photo 11). The kettle's thermostat switch and indicator lamp in this vicinity were consumed by the fire. No evidence of adverse electrical activity was observed on the kettle's internal electrical connections or terminals.

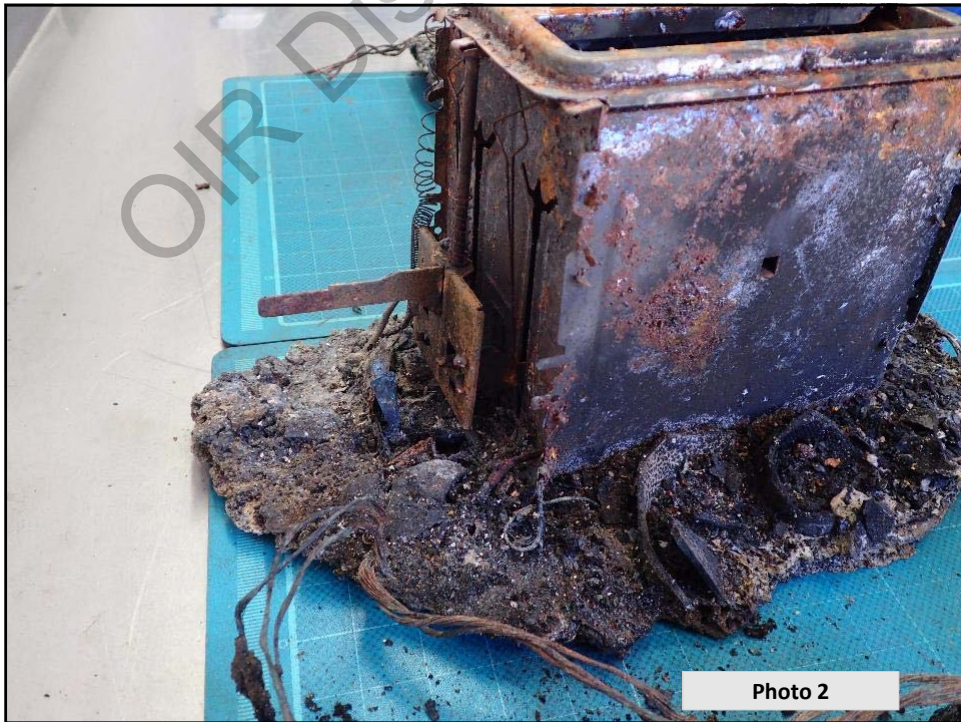
2

The submitted toaster was badly damaged by fire with all the plastic components and original enclosure consumed leaving only the metal frame and mechanism. The make and model of the toaster could not be identified. The toaster was also too badly damaged by fire to show any evidence of adverse electrical activity. The double leaf-spring switch that disconnected the power when the toaster's carriage was in the up position was damaged with one contact missing (Photo 12), however the leaf-spring switch contacts that could be seen appeared to be in good order. (Photo 13).

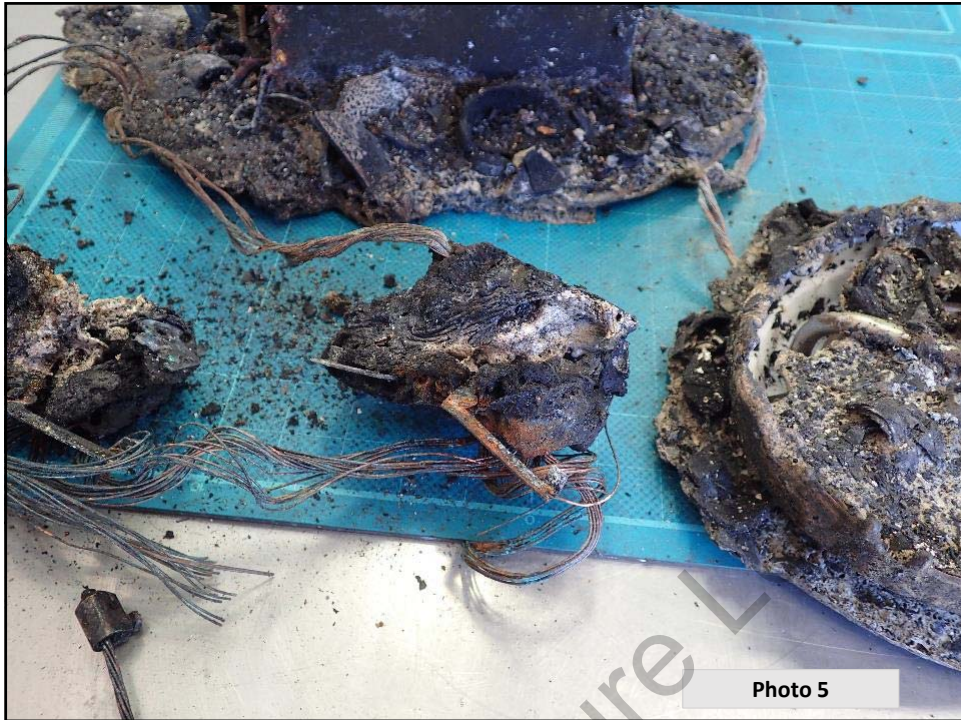
Photo 5

The plastic enclosure and assembly of both of the socket outlets appeared badly melted from direct external radiant heat. Both outlets' internal metal bus bars and terminal connections survived the fire and short lengths of building cable could be seen still attached. These cable connections were all found to be terminated correctly. Because of fire damage it was not possible to determine if the outlets were switched on or off at the time of the fire. Two three pin plugs were observed inserted in each of the wall socket outlets (Photos 7 & 8). These were found still connected to the kettle and toaster via their respective supply flexible leads and plugs. There was no evidence of any additional plugs being inserted into the wall socket outlets. No evidence of adverse electrical activity could be observed on the surviving metal bus bars, terminals of the wall socket outlets or the building cable conductors. The pattern of damage was consistent with exposure to radiant heat and these wall socket outlets were eliminated as potential points of fire origin.

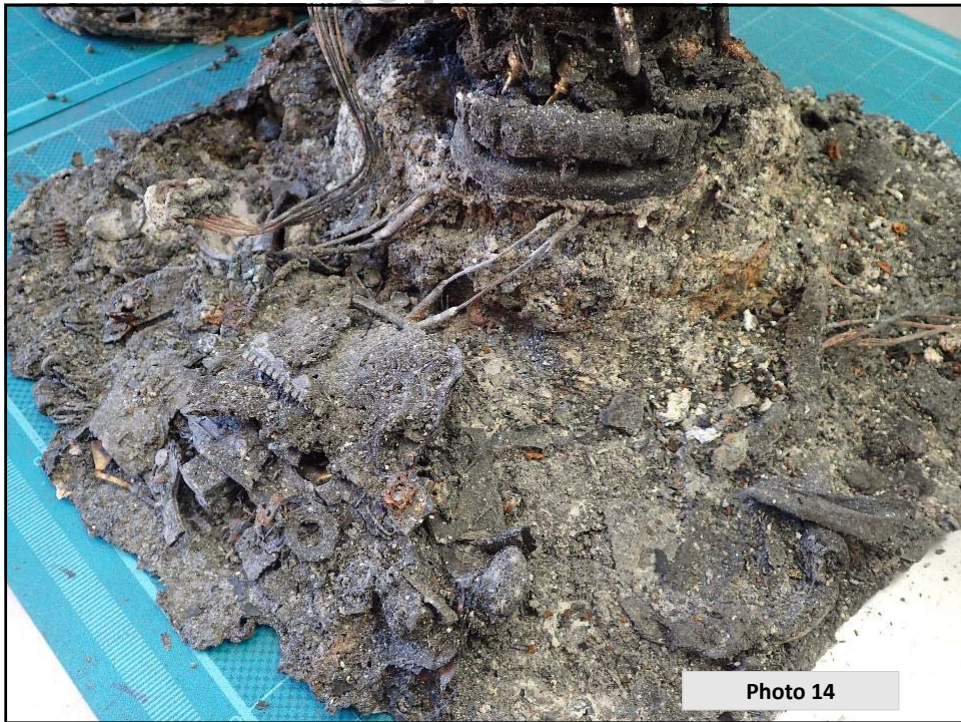
14

The Thermomix model kitchen machine was also badly damaged with the plastic components and enclosure melted down (Photo 14). The metal bowl of the Thermomix that survived the fire was still in an upright position and showed no particular concentration or pattern of fire damage on its inside (Photo 15). It appeared to have been affected by radiant heat damage only. No adverse electrical activity could be observed on the surviving conductors or terminals of this kitchen machine. The Thermomix's plug and supply flexible cord was missing and therefore no evidence the Thermomix was connected to electricity at the time of the fire could be found.

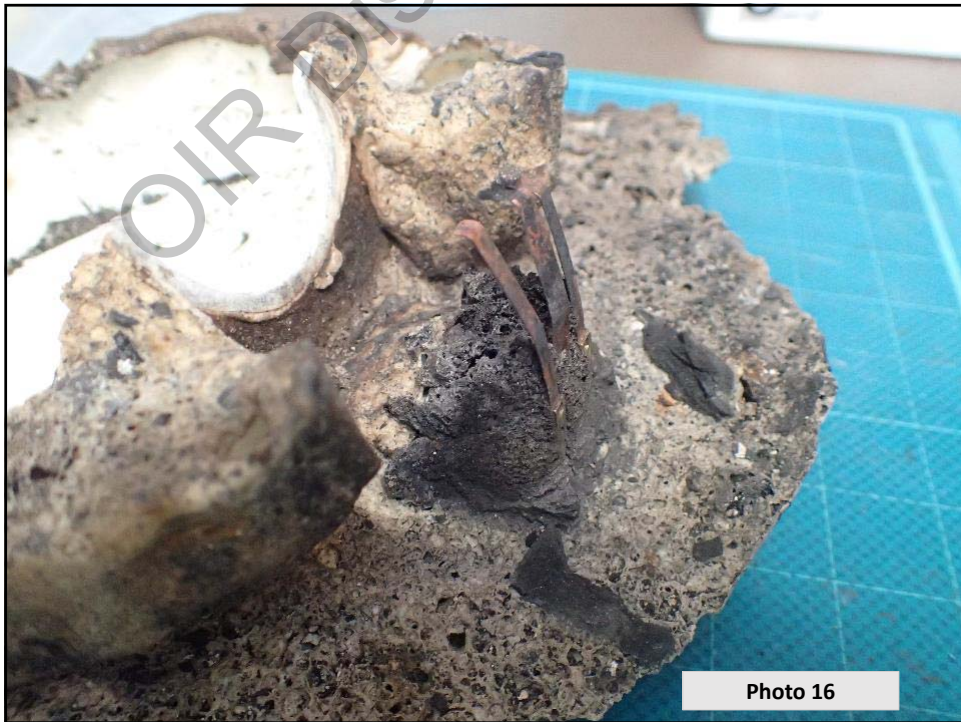
16

The pattern of damage around the location of the kettle's cordless connector and thermostat switch is consistent with an overheating event (Photo 16). Even though no direct evidence of an arc tracking event could be seen on the cordless connector conductors, the very localised charring of the plastic could be indirect evidence of arc tracking. However, it is not possible to determine if this is insulation breakdown was a cause or consequence of the fire.
