Workplace Health and Safety Electrical Safety Office Workers' Compensation Regulator

Falls from fixed ladders with cages

Issued: 17/05/2019 Last Updated: 17/05/2019

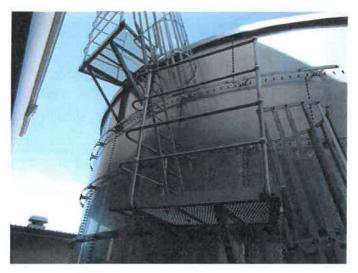
Photograph 1. Inclined caged ladder with additional rails installed to extend the height of the existing top guardrail.

The likelihood someone falling from the caged ladder and over the guardrail can be reduced by minimising the unguarded area between the cage and the top guardrail (distance 'A' in Diagram 1). Examples of control measures which would minimise the unguarded area between the cage and top guardrail are shown in Photographs 1 and 2.

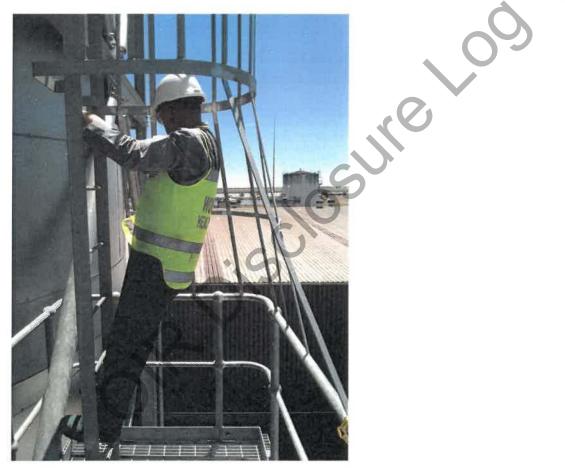
Photograph 2. The bottom of this vertical caged ladder has been flared out and extended down to the top guardrail.

Fixed ladders that are vertical or close to vertical (e.g. sloped greater than 75° to the horizontal, refer to Photograph 2) are generally more difficult to climb. This increases the likelihood of a person falling off the ladder. Owners of fixed ladders, with or without a cage, that are sloped greater than 75° should consider fitting a permanent or temporary fallarrest system to the ladder.
