## Electrical Equipment Incident Report

REPORT NUMBER: IR201632f

<b>EQUIPMENT TYPE:</b>	Liquid Heating Appliance	Bread Toaster	Socket Outlet	Kitchen Machine
<b>BRAND/TRADENAME:</b>	Home&Co	Unknown	Unknown	Vorwerk
<b>DETAILS:</b>	WK831, 240V, 1850-2200W	Unknown	Unknown	Thermomix 31-1, 220-240V~,50/60Hz 1500W
<b>HAZARD CLASSIFICATION:</b>	Fire			
<b>INCIDENT LOCATION:</b> <small>(SUBURB)</small>	DUGANDAN

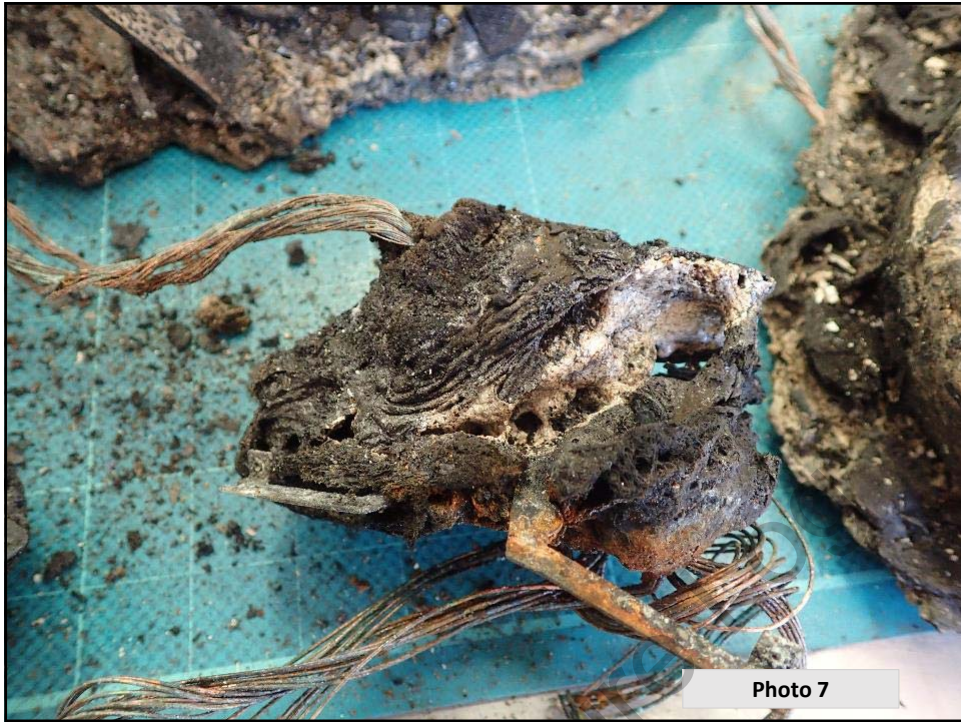
Photo 6

The plastic enclosure and assembly of both of the socket outlets appeared badly melted from direct external radiant heat. Both outlets' internal metal bus bars and terminal connections survived the fire and short lengths of building cable could be seen still attached. These cable connections were all found to be terminated correctly. Because of fire damage it was not possible to determine if the outlets were switched on or off at the time of the fire. Two three pin plugs were observed inserted in each of the wall socket outlets (Photos 7 & 8). These were found still connected to the kettle and toaster via their respective supply flexible leads and plugs. There was no evidence of any additional plugs being inserted into the wall socket outlets. No evidence of adverse electrical activity could be observed on the surviving metal bus bars, terminals of the wall socket outlets or the building cable conductors. The pattern of damage was consistent with exposure to radiant heat and these wall socket outlets were eliminated as potential points of fire origin.
